**GREAT EAST LAKE  
DAM-BREACH FLOOD ANALYSIS  
WAKEFIELD, NEW HAMPSHIRE &  
NEWFIELD, MAINE**

GREAT EAST LAKE  
DAM-BREACH  
FLOOD ANALYSIS

Wakefield, New Hampshire  
and  
Newfield, Maine

Water Management Section  
Geotechnical and Water Management Branch  
Engineering/Planning Division

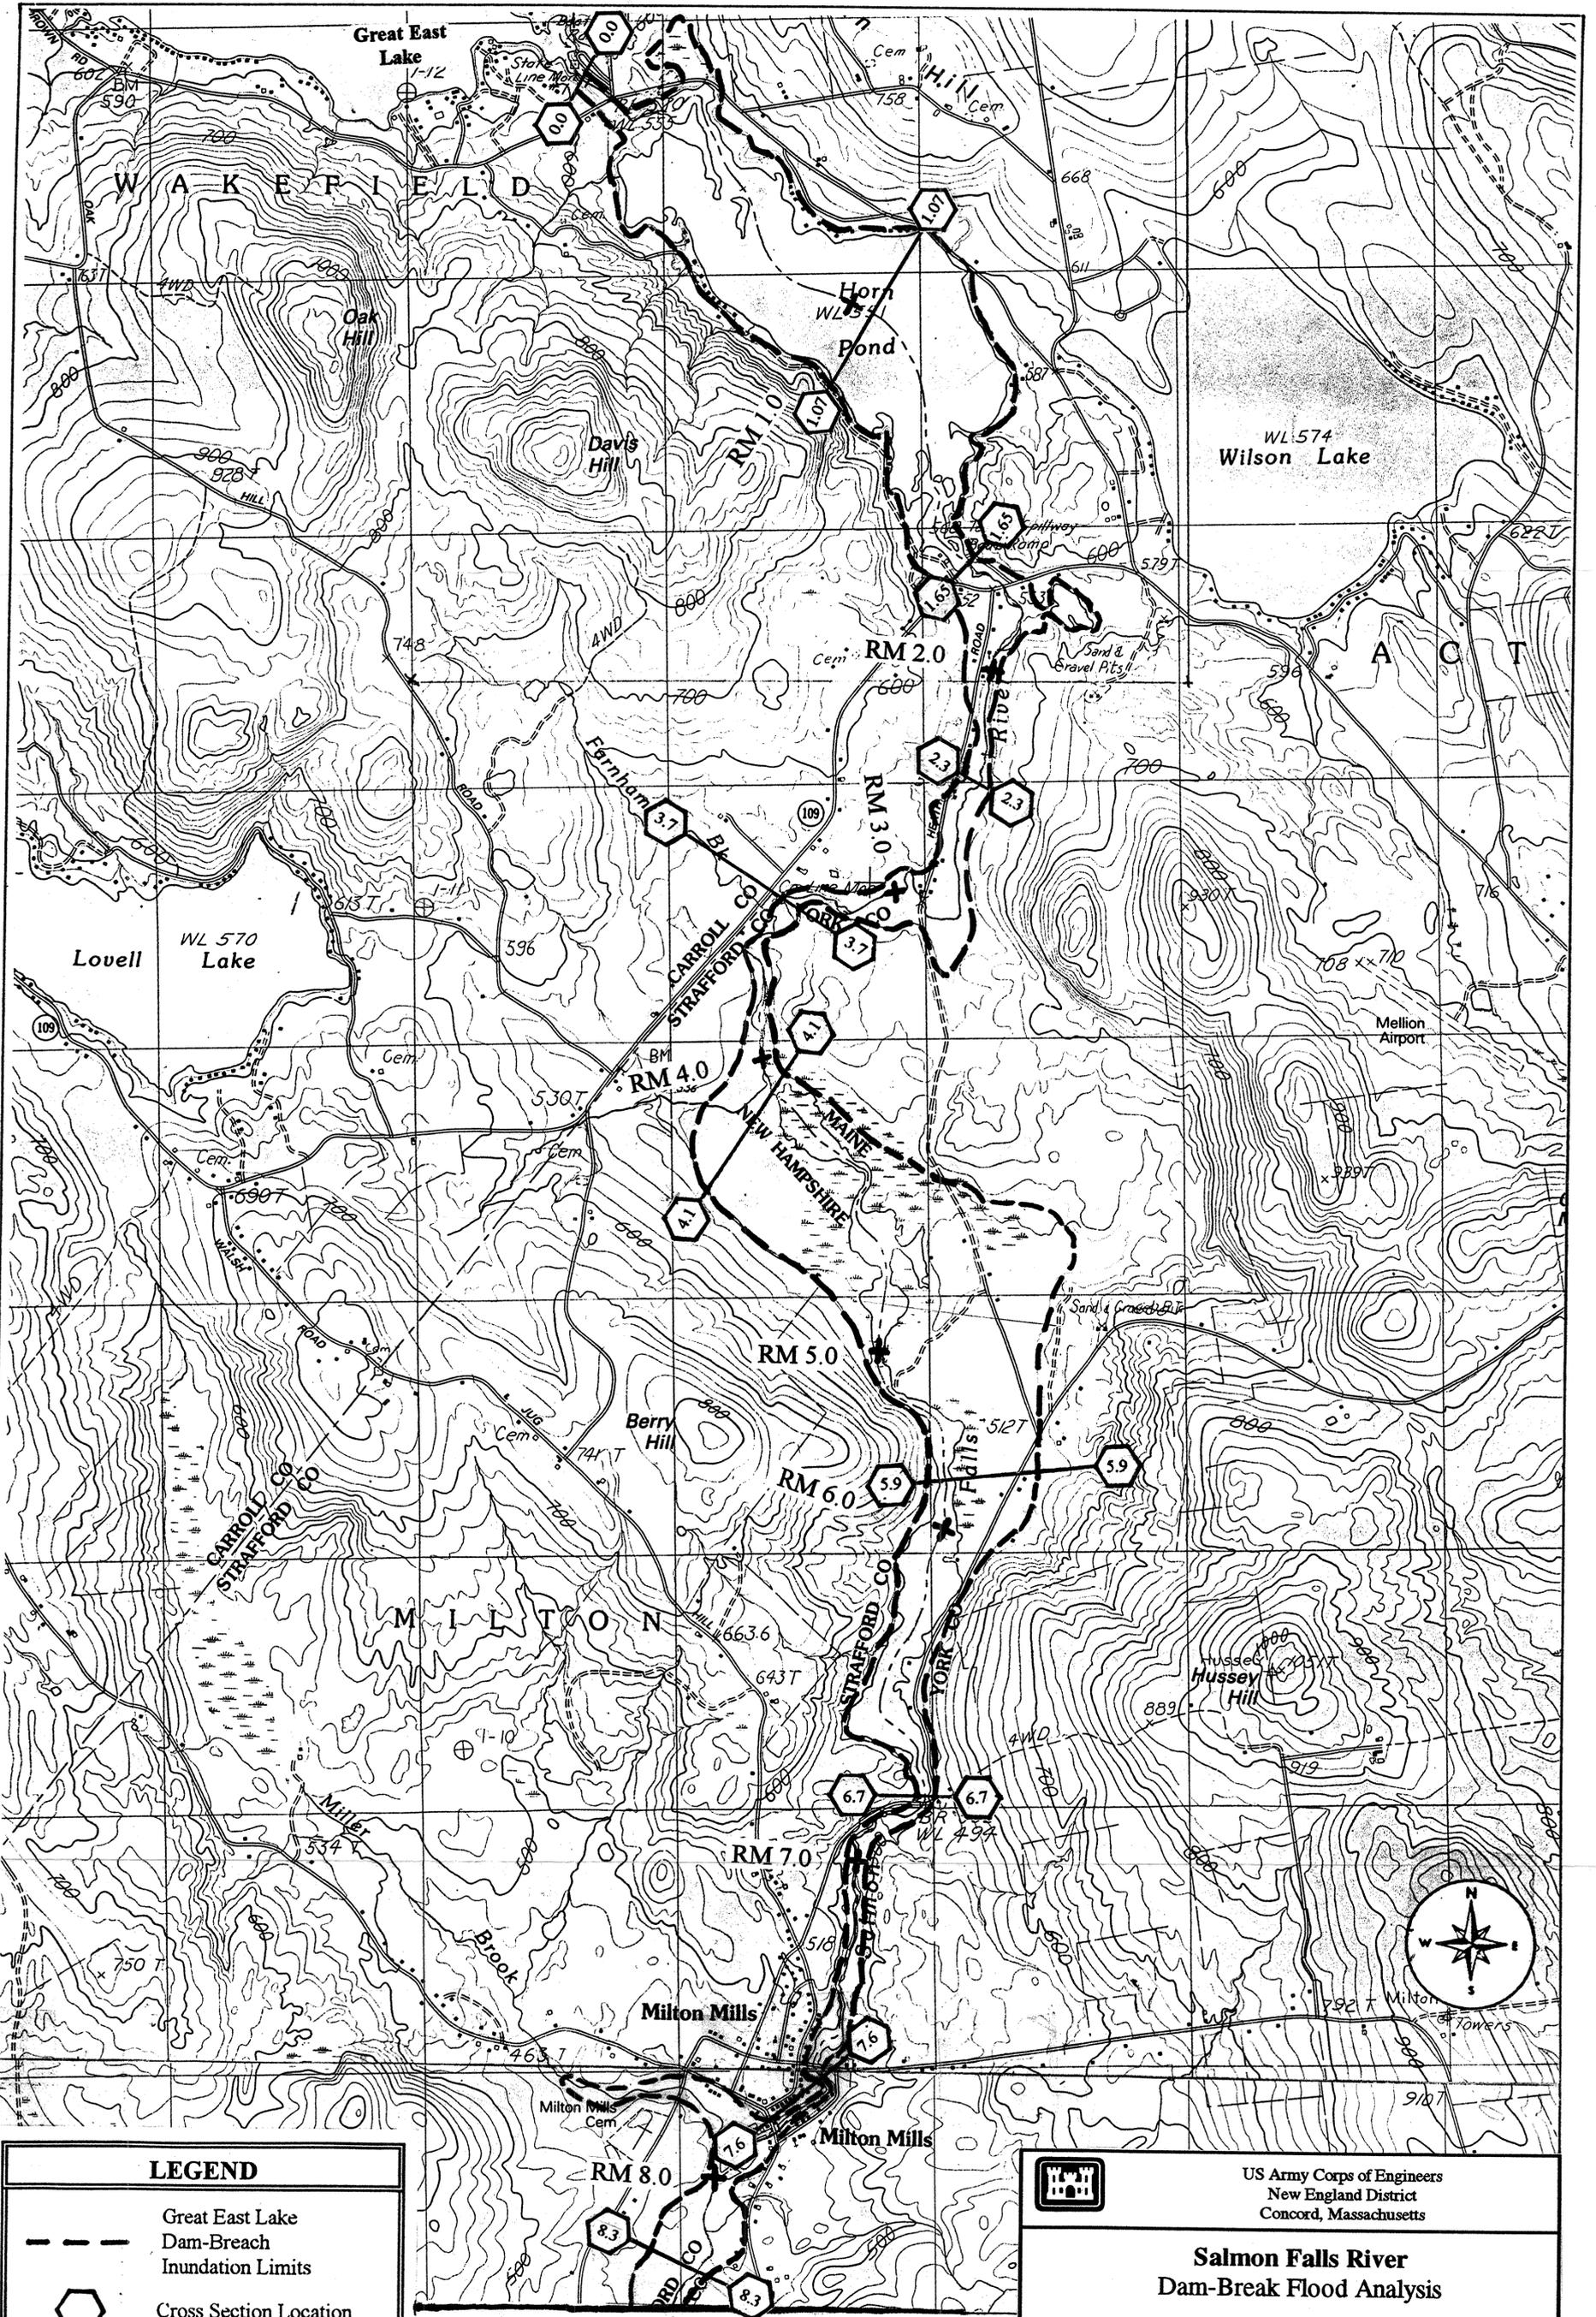
US Army Corps of Engineers New England District Concord, Massachusetts
	<b>Salmon Falls River</b> Dam-Break Flood Analysis
	<b>INUNDATION MAPPING</b> Sheet 1 of 2

LEGEND	
	Great East Lake Dam-Breach Inundation Limits
	Cross Section Location
	River Miles Downstream From Great East Lake Dam

Match Line - Sheet 2  
 SCALE: 1" : 1,000' Contour Interval 20 Feet

The limits of inundation were computed by routing the breach discharge hydrograph through the downstream valley cross sections and delineating the resulting maximum stages on the base map. The base map used is based on a 20-foot contour interval 1:24,000 scale USGS quadrangle and, therefore, inundation limits shown on Plates 3 and 4 are only approximate. Inundation mapping with a larger scale of 1":1,000' is provided in Appendix I. Locations of the twenty selected downstream stations are graphically illustrated on Plates 3 and 4. Although any structures shown within these limits were assumed to be inundated, certain structures may be excluded as a result of local conditions and elevations.

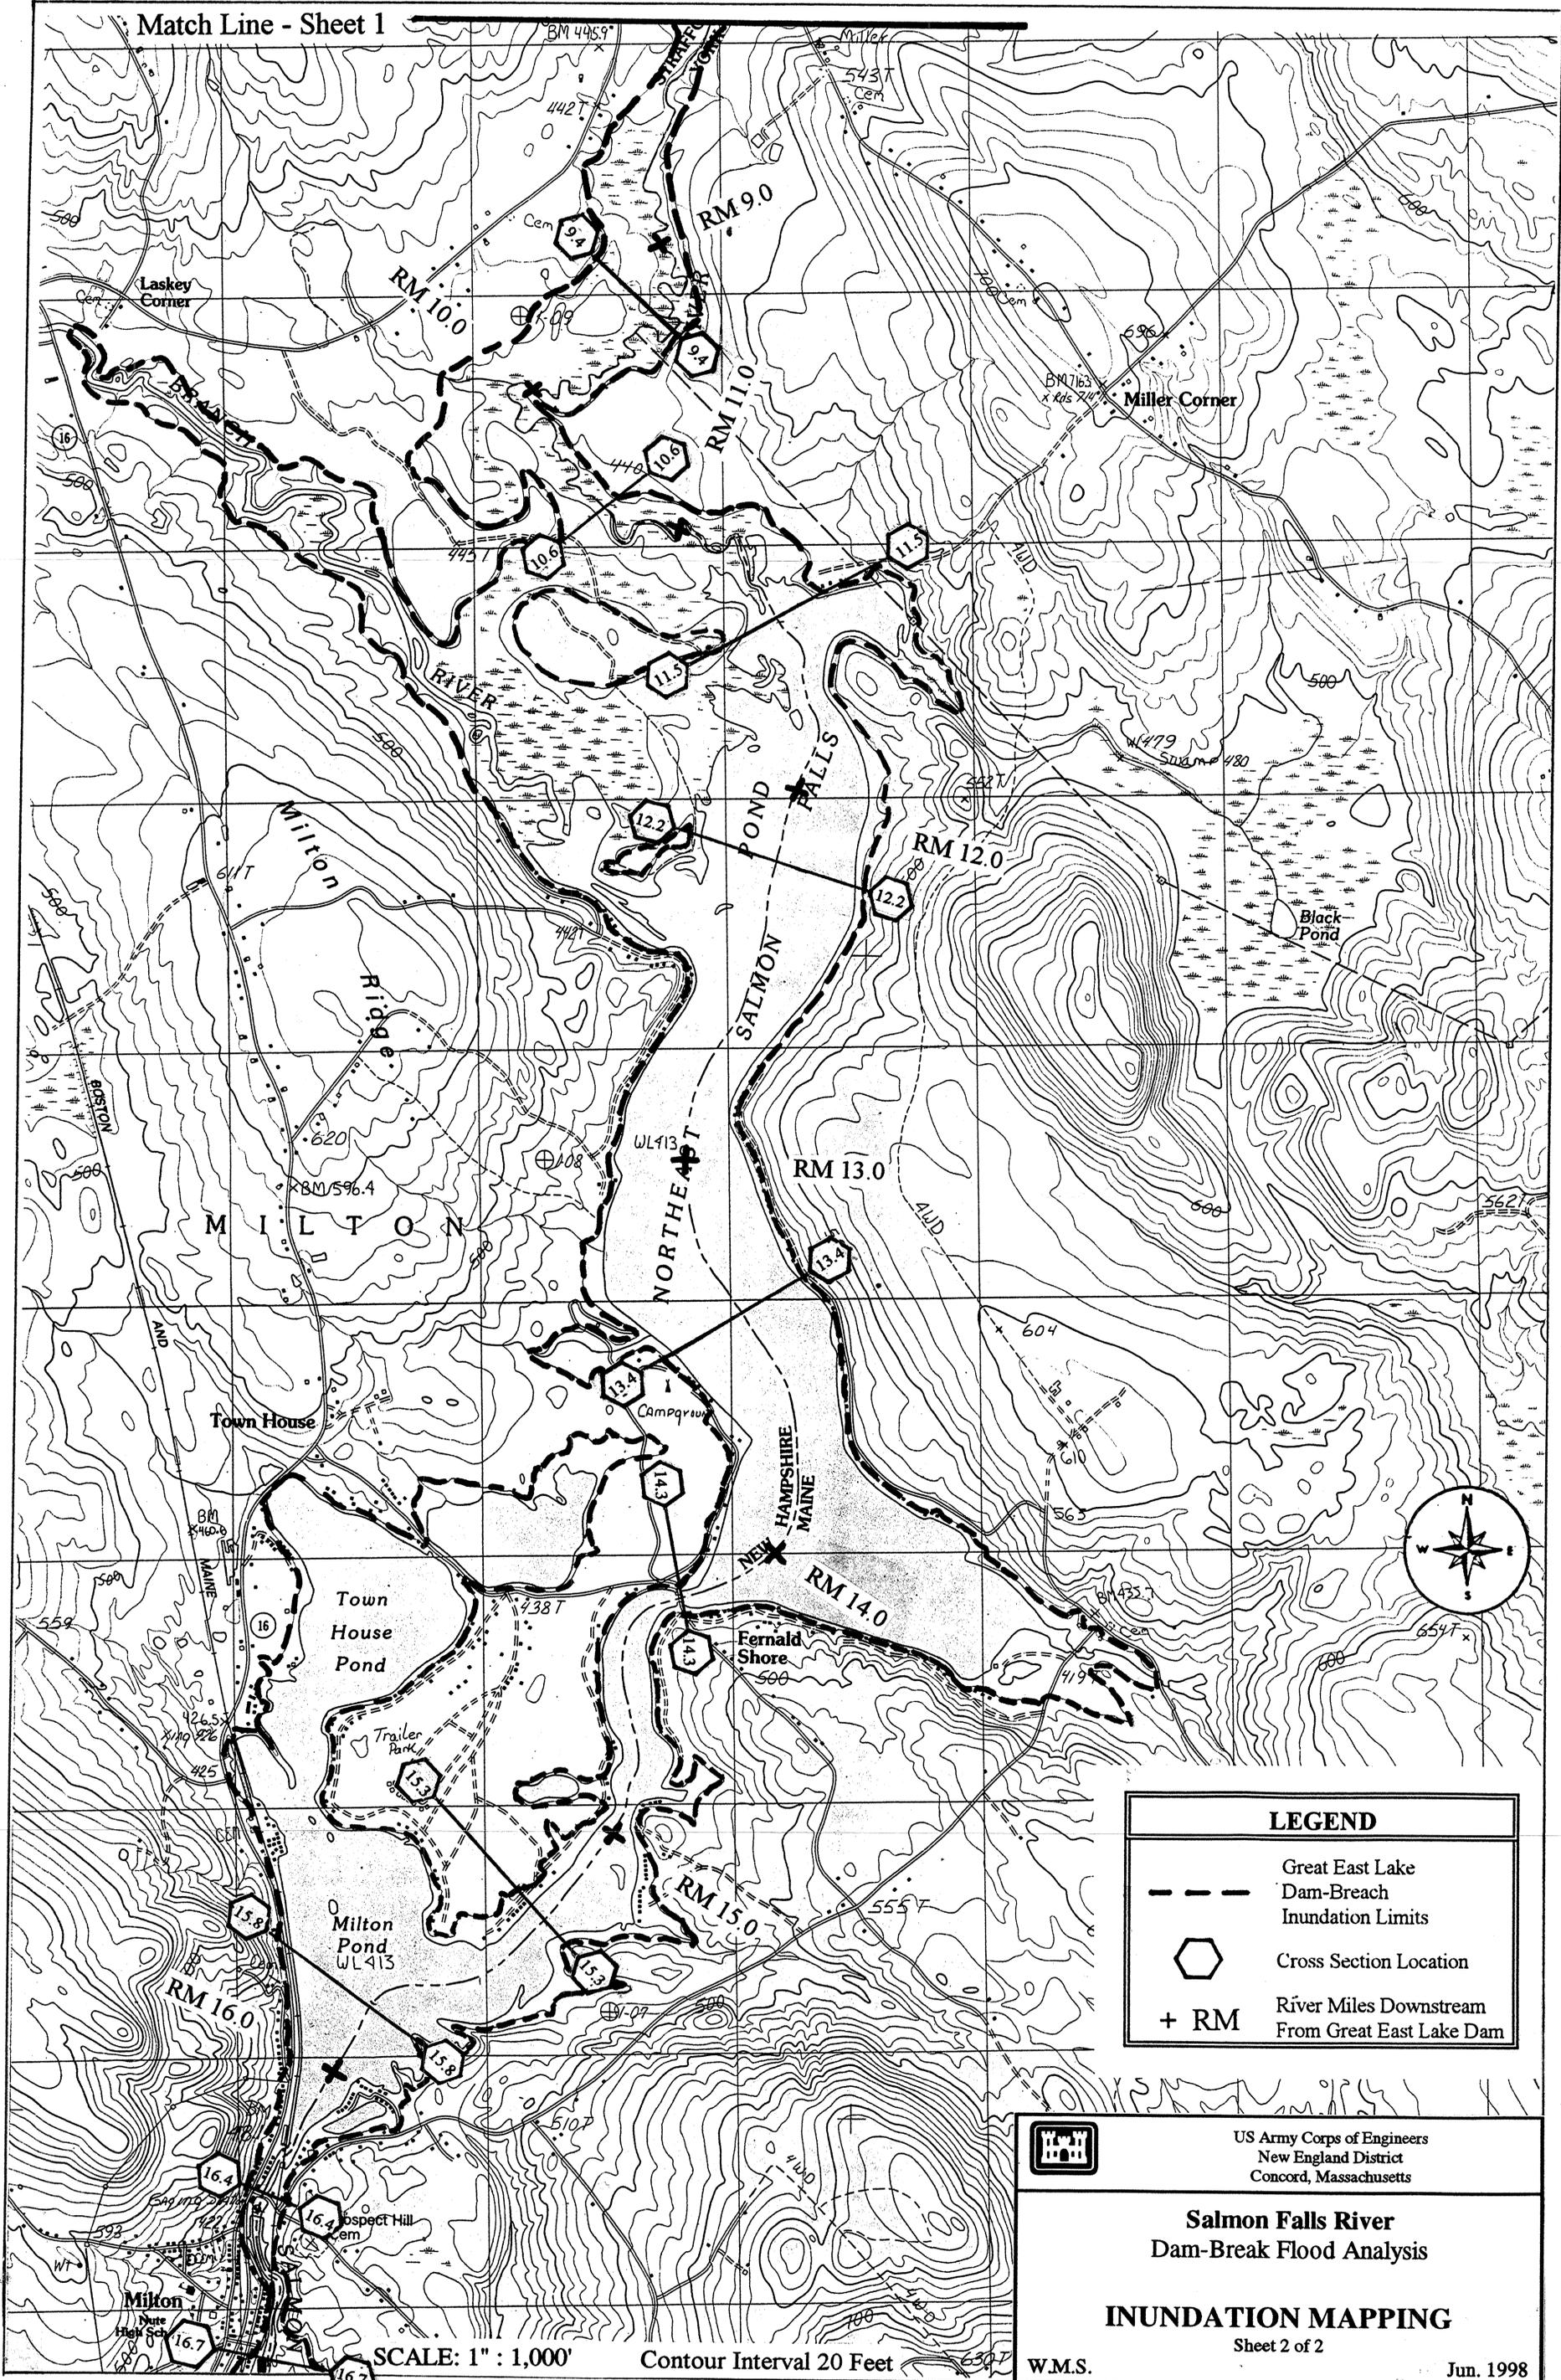
LEGEND	
	Great East Lake Dam-Breach Inundation Limits
	Cross Section Location
	River Miles Downstream From Great East Lake Dam
